Covanta Miami-Dade

2020 Facility Performance

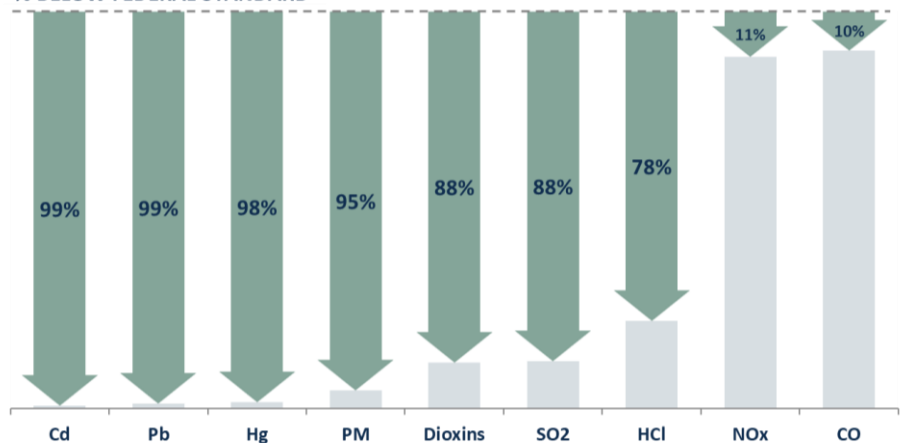
2018-2020 WTE Emissions Compared to Federal Standards

The facility operates up to **99% below** federal emissions standards

Emissions compared to federal guidelines for existing facilities (40 CFR 60 Subpart Cb). Facility may be subject to more stringent requirements by permit or in accordance with other federal guidelines.

% BELOW FEDERAL STANDARD

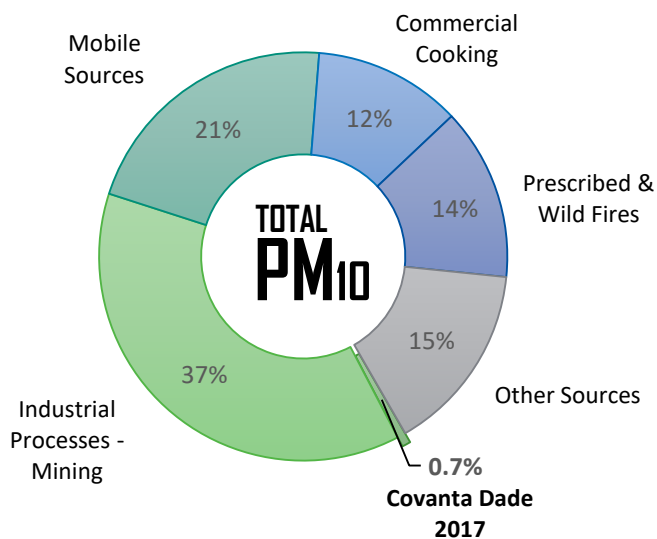
How Do Our Emissions Compare to Other Sources in the County?

Local air emissions* in Miami-Dade County, FL

Excluding Dust Sources, which make up 60% of the total inventory.

* Based on the 2017 US EPA National Emissions Inventory; the most recently released complete inventory. Where available, the facility's 2017 emissions were replaced with the reported 2020 emissions.
